TECH TIP

from the ATARI FIELD SERVICE DEPARTMENT

10-13-87

ROADBLASTER

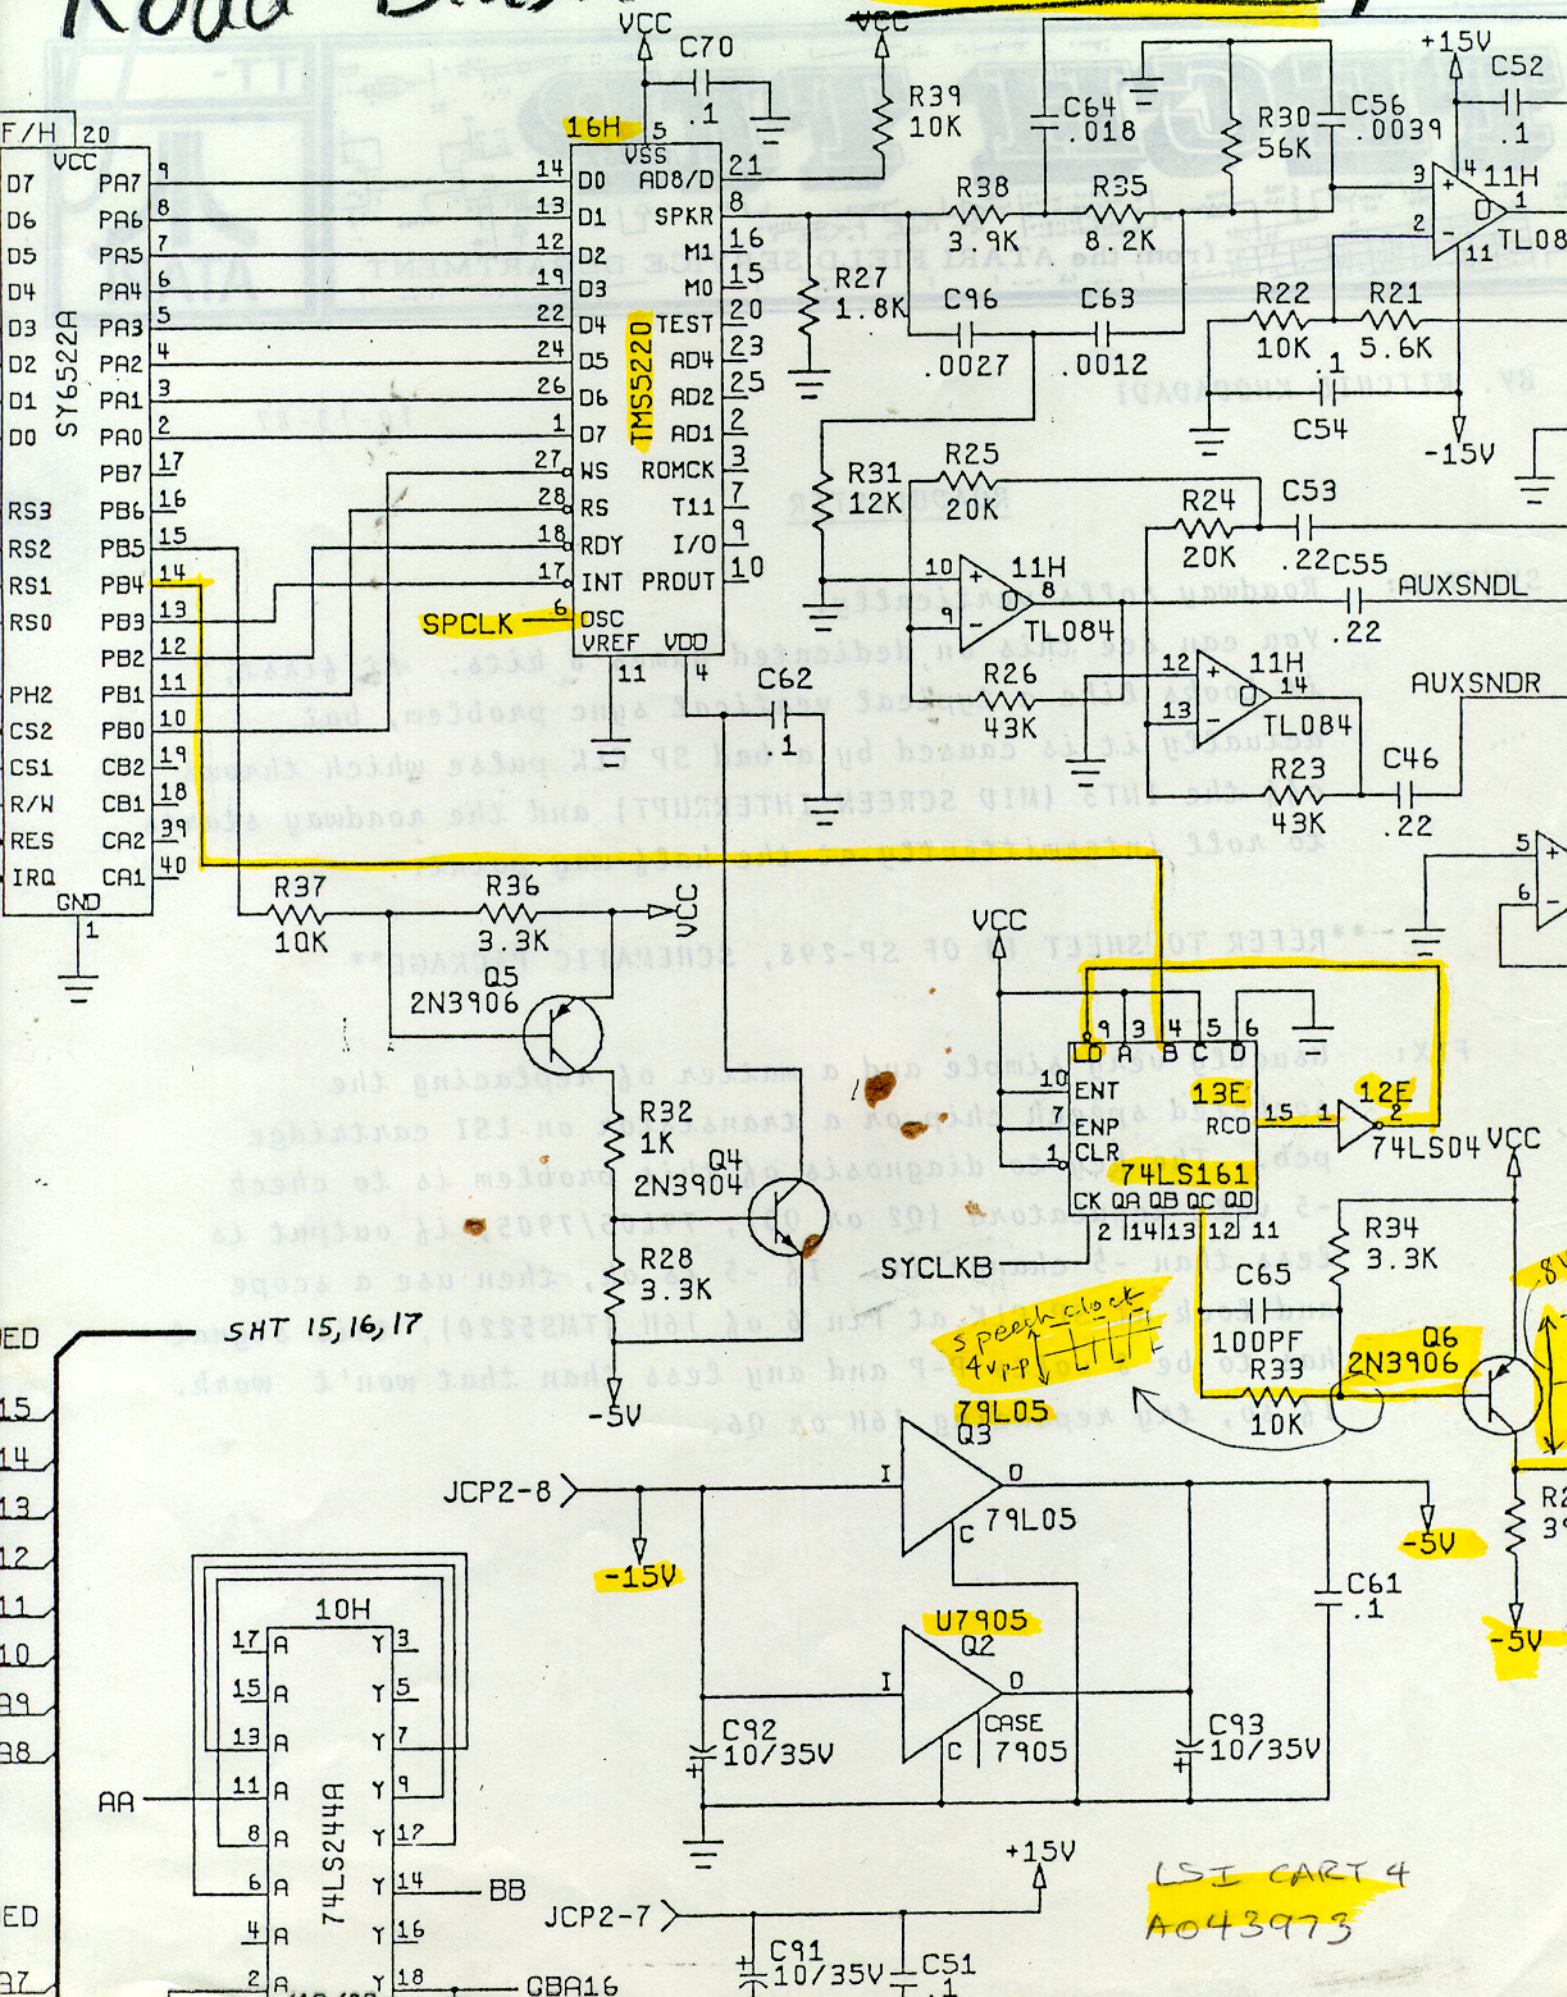
Road Blaster Vertical Roll problem

SYMPTOM: Roadway rolls vertically.
You can see this on dedicated games & kits. At first, it looks like a typical vertical sync problem, but actually it is caused by a bad SP CLK pulse which throws off the INT3 (MID SCREEN INTERRUPT) and the roadway starts to roll intermittently at the half-way point.

FIX: Usually very simple and a matter of replacing the socketed speech chip or a transistor on LSI cartridge pcb. The key to diagnosis of this problem is to check -5 volt regulators (Q2 or Q3), 79L05/7905, if output is less than -5 change it. If -5 is ok, then use a scope and look at SP CLK at Pin 6 of 16H (TMS5220), this signal has to be 8 volts P-P and any less than that won't work. If so, try replacing 16H or Q6.
